Ground Motion Characteristics of the 2015 Gorkha Earthquake, Survey of Damage to Stone Masonry Structures and Structural Field Tests

Rishi Ram Parajuli^{1*} and Junji Kiyono²

Keywords: Gorkha earthquake, ground motion characteristics, damage survey, stone masonry, field test, Schmidt hammer test

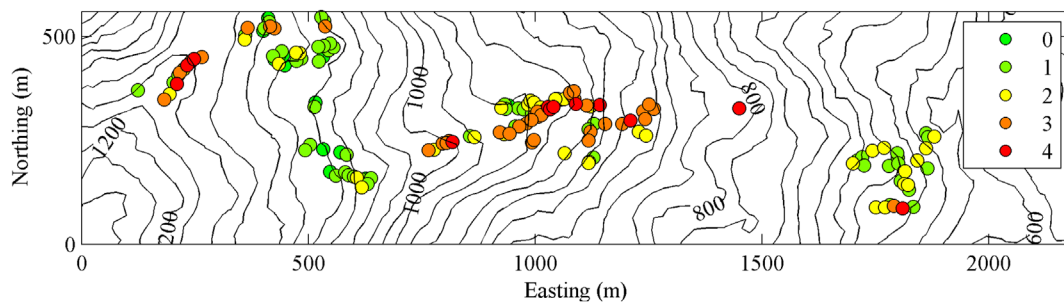
FIGURE 7 | Topographic map of the study area showing structural damage grade.

In the study cluster, there are 149 structures consisting of 58 large, 68 medium, and 23 small-sized buildings with 39, 46, and 15% of weightage, respectively. Damage grade and location were recorded using GPS at the site. **Figure 7** shows the damaged structures on a topographic map. Green colored dots represent grade 0 structures, whereas red dots represent the location of grade 4 structures (as we do not have any grade 5 structures). **Figure 8** shows the damage grade of structures with percentages of structures that include categories of structure sizes. We found that 8% of the structures had a damage grade of 0; 38% were in grade 1; and grade 2 and grade 3 structures were 24% each. The remaining 6% of the structures were damaged severely, at grade 4.

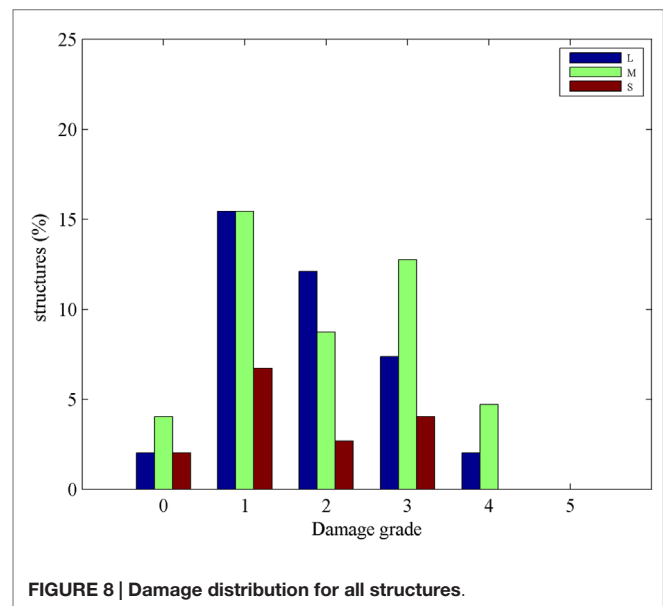
Here, we can see most of the structures fall under damage grades 1, 2, and 3, with less coming from grades 0 and 4. From the survey, we found that most of the buildings on ridge lines suffered heavy damage but those on side-slopes were not damaged as much. The study area comprises an area that includes a mountain ridge along with a local ridge line formed on the middle of the slope. Hence, we categorized the structures as ridge-line structures, those that are located on the ridge line. There are a total of 52 structures located on the ridge line, including the main and local ridge lines. Damage grade details of the structures on the ridge line are shown in **Figure 9**. There are no structures that fall under grade 0; in fact only 15% of the structures graded as 1 with 19% in grade 2. More than half of the structures, i.e., 52%, were grade 3 and the remaining 14% fell under grade 4. A small structure that was graded as 3 on the ridge line is shown in Image S1 in Supplementary Material.

FIGURE 8 | Damage distribution for all structures.

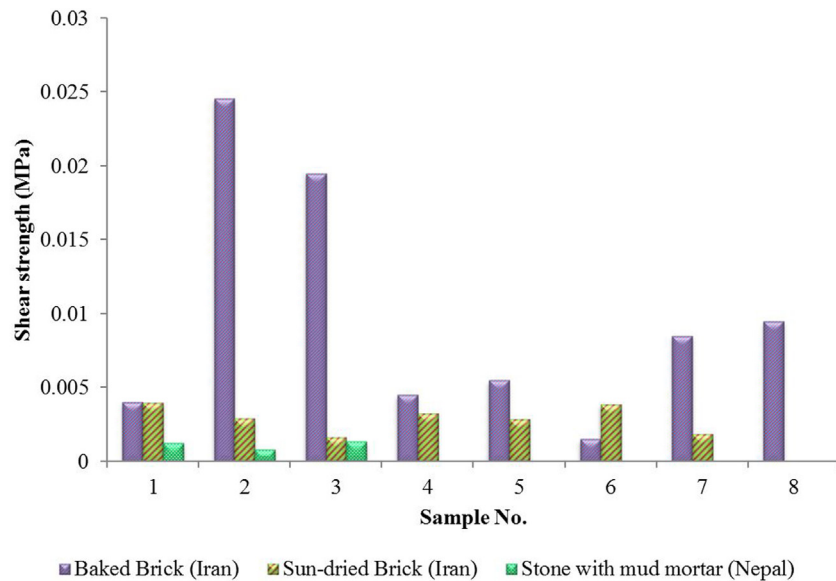
strengths of mortar bonding were estimated to be 0.0029 and 0.0097 MPa, respectively. The frictional coefficient for the joint was found to be 0.62 and 0.54, respectively, for sun dried and baked brick masonry. Test results from Nepal show that the frictional coefficient lies between the values of sun-dried and baked masonry structures in Iran, but shear bonding strength is much lower than that of both brick masonry structures.

**FIGURE 10 | Comparison of the shear strength of stone masonry with mud mortar joint in Nepal with shear strength of brick masonry wall joints in Bam, Iran.**
